# Bridge Management

**Inspection,  
maintenance,  
assessment  
and repair**

This volume contains the papers presented at the Third International Conference on Bridge Management, held at the University of Surrey, Guildford, UK, on 14–17 April 1996.

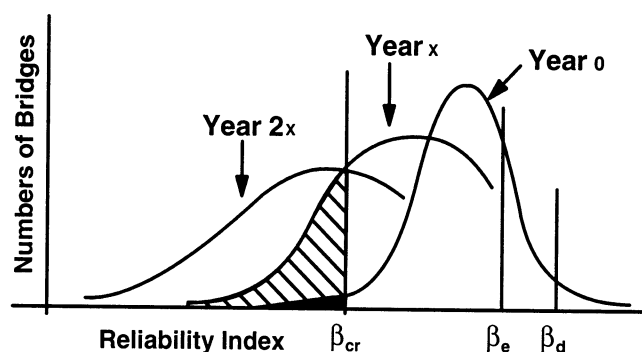
Fig. 1. Bridge safety deterioration.

Let us assume, for the purpose of a schematic representation, that the reliability index  $\beta$  for the whole population of the bridge stock is individually calculated and the number of bridges for each value of  $\beta$  is expressed in a distribution graph as shown in Fig. 1. The newer bridges are likely to be on the right of this distribution and some "at risk" bridges such as those with severe deterioration, or those regularly affected by flooding, HGV collision, or those with ASR, are likely to be located towards the left. Let us assume that the bridges to the left of  $\beta_{CR}$  are those that are either showing clear signs of distress, or are calculated to have a critically low factor of safety i.e. are liable to fail at any time.

It is reasonable to expect that, without any management action, the overall reliability distribution of the bridge stock will tend to move leftwards. Some bridges will of course deteriorate much more slowly than others. If the bridges with  $\beta$  less than  $\beta_{CR}$  are the only ones repaired or replaced at year 0, after a period of time, say at year  $x$ , the number of bridges to be repaired will be much greater, as shown in Fig. 1. After a number of similar periods the numbers of bridges to be strengthened could reach unmanageable proportions. The overall purpose of bridge management is, therefore, to prevent such a scenario from developing. For this reason, some form of intervention has to take place well before bridges reach the stage indicated by  $\beta < \beta_{CR}$ . In order to carry out such intervention in the form of strengthening or replacement, as large numbers will be involved, selected groups of bridges have to be assessed for their reliability. The purpose of the assessment is to identify those bridges that have deteriorated beyond a particular condition point, say  $\beta_e$ ,  $\beta_e$  being the target reliability for assessment. The assessment criteria corresponding to  $\beta_e$  will normally be less

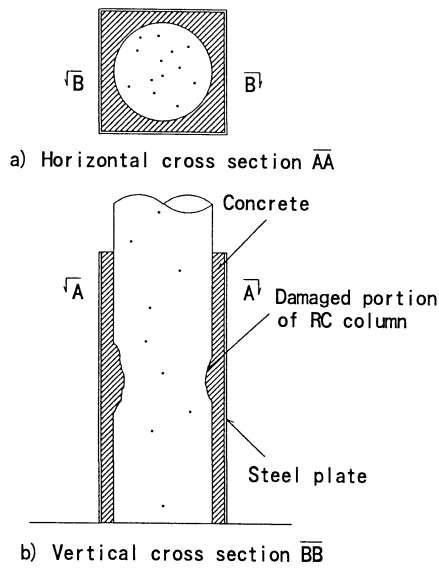
Fig. 2. Emergency repair for damaged concrete pier.

pier and filling concrete between the pier and these steel plates as shown in Fig. 2. The buckled plates of a steel pier are repaired by adding stiffeners welded on their outer surfaces as illustrated in Fig. 3. These emergency repairs were performed within about one month of the occurrence of the earthquake.

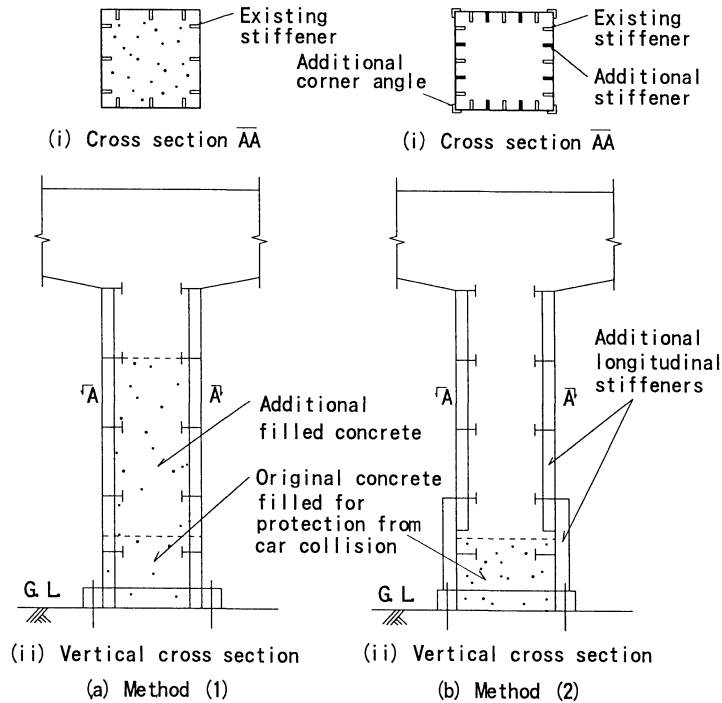
Fig. 5. Typical alternative methods for improvement of existing pier.

now under examination is shown in Fig. 5 (b), in which longitudinal stiffeners or corner angles are added to the stiffened plates of a steel pier. The new anchor bolts should be added at the base of the pier, if the strength of existing anchor bolts is insufficient to resist strong earthquakes.

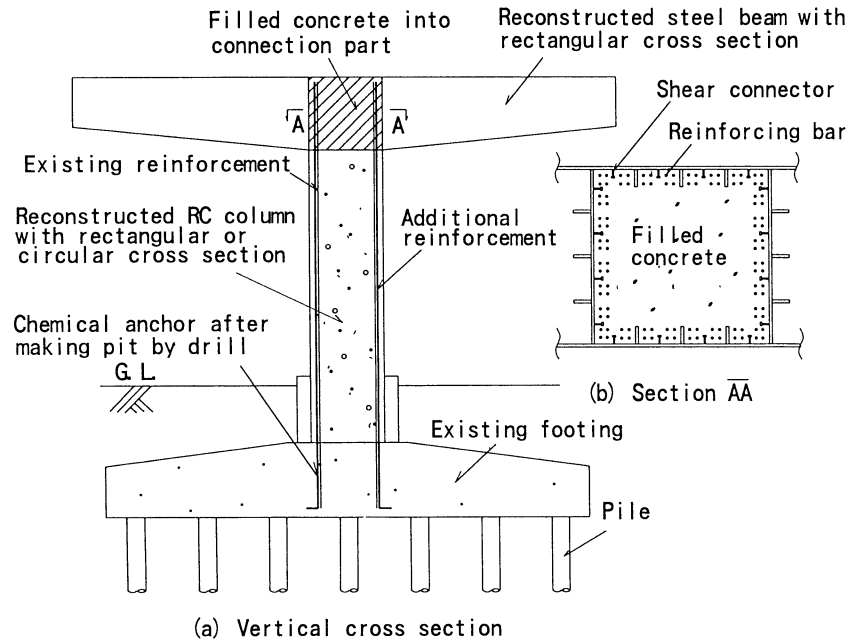
Fig. 6. Hybrid pier with RC column and steel cross beam.

2. The appropriate shear connectors are arranged on the inner surfaces of the flange and web plates of the steel beam.
3. Concrete with plasticiser and expansive additive is placed into the connection.  
The strength and ductility of the hybrid pier has been assured through experiment.

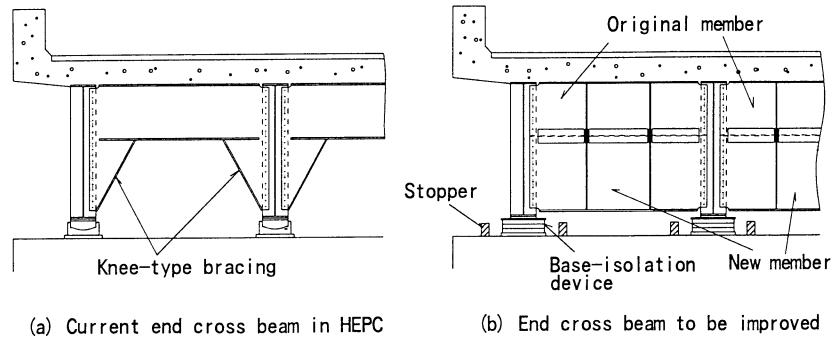
Fig. 7. Improvement of end cross beam.

Stoppers, for preventing bridges from falling, are newly installed on the pier in the case of special bridges such as curved bridges with a small radius of curvature, skew bridges, cantilever bridges, bridges with high bearing-height, etc. (see Figs. 7 and 8).

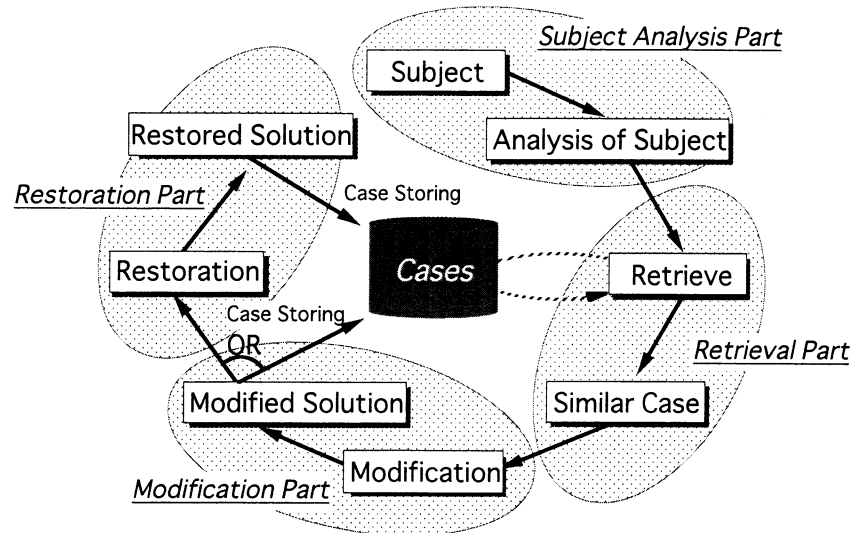
Fig. 2. Case-based reasoning.

In case-based reasoning, a case database is first built up by accumulating collected cases systematically on the basis of their characteristics. Then, this database is retrieved for cases (including failure cases) in the past similar to a given subject, and the problems are solved by modifying the solutions. Case-based reasoning stands between "rule-based reasoning" where reasoning is conducted based on only rules and "model-based reasoning" where, a large-scale case database being used, reasoning is conducted based on only matching. Case-based reasoning is constituted as shown in Fig. 2, and functions of its constituents are as follows:

1. *Subject Analysis Part*: Index information to retrieve for similar cases in the past is extracted from the subject.
2. *Retrieval Part*: The index information obtained in the Subject Analysis Part being used, the case database is retrieved for similar cases in the past. If a case extracted by search coincides with the subject case, the search result can, as it is, be used as a solution of the subject. Abstraction matching, partial matching, causal matching, and so forth are available as matching methods.

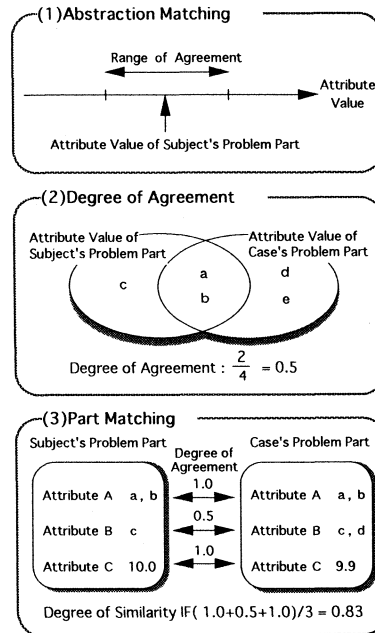
Fig. 4. Retrieval method.

4.3.3 Partial matching of cases (Fig. 4 (3))

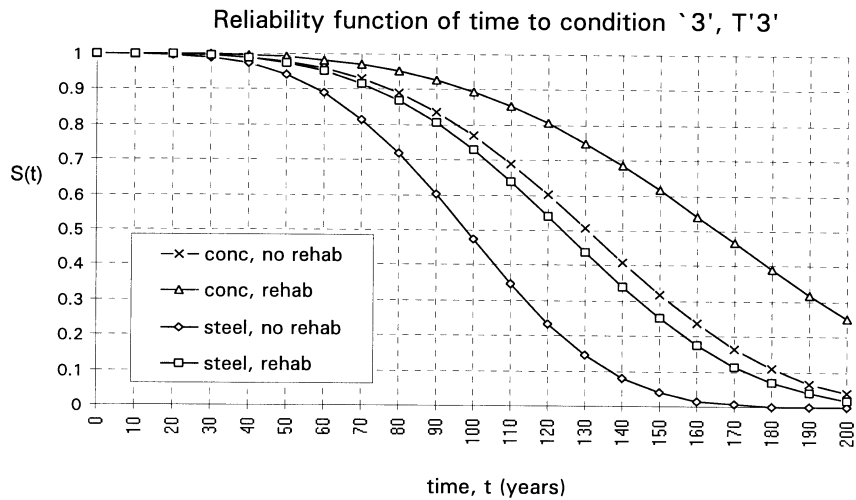
Fig. 1. Reliability functions of bridges fitted by Weibull distribution.

This is indeed the non-parametric estimator for  $P\{T>t\}$ ; viz., the reliability function.

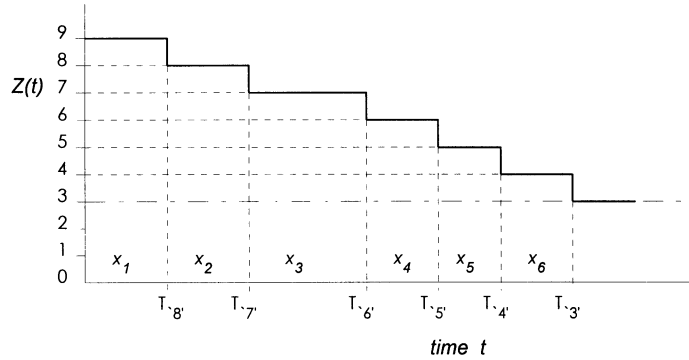
Fig. 2. A sample function of bridge deterioration process.

To further investigate the nature of the reliability function we proceeded to derive a homogeneous Markov chain from the survival model. By successively redefining the limiting value for 'failure', as condition ratings '3', '4', ..., '8'; and performing the survival analysis in each case, we obtained distributions of  $T_{\cdot 3}$ ,  $T_{\cdot 4}$ , ...,  $T_{\cdot 8}$ . These distributions together give a complete description of the deterioration process, as illustrated in Fig. 2.

The random variable  $X_i$  is the duration that the process takes to stay in state  $i$  and is sometimes called the *sojourn time*. Notice that if  $X_1, X_2, \dots$ , have independent and identical exponential distributions we would have a continuous-time Markov process. In the present case, they are neither exponential nor identical.

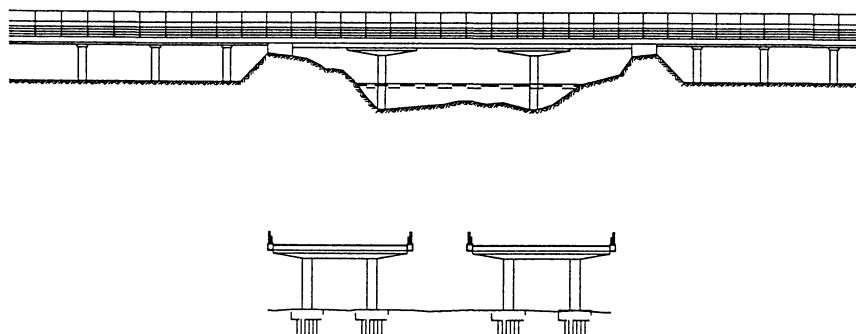
Fig. 1. Illustration of the Gudenå bridge structure.

A requirement for the load carrying capacity of the bridge, was that it should comply with bridge classification 100 (the class roughly corresponds to the maximum allowable load - in tons - from an extraordinary vehicle, applied simultaneously with an ordinary - 50 ton - vehicle) with reasonable maintenance costs for a residual service life exceeding 20 years.

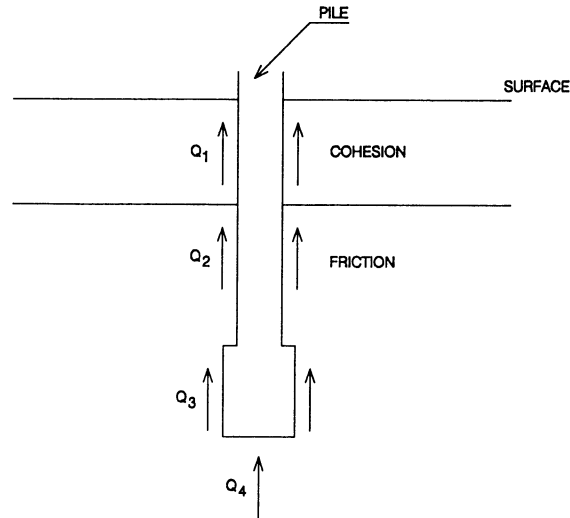
Fig. 3. Principal illustration of the pile and the soil structure.

$Q_4$  is the contribution from the pile tip.

It may be assumed that the pile tip carrying capacity at the time of the pile driving can be estimated from the pile driving journals and by application of the standard pile driving formula from the Danish codes (DDR). However, by comparison of pile load carrying capacities determined by the DDR and static pile capacity tests performed immediately after pile driving, see e.g. [4] a discrepancy is observed.

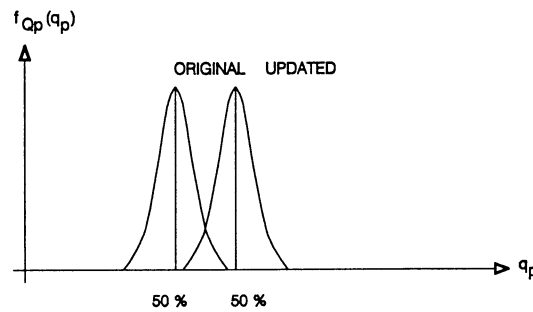
Fig. 4. Illustration of the probability density function of the compression strength for one of the analysed piles, before and after, additional pile compression strength tests.

The probability density function for one of the piles is illustrated in Fig. 4.

Based on the updated probabilistic models for the pile compression strengths, updated probability distribution functions were established as illustrated in Fig. 4. In general the mean values of the pile compression strengths were increased significantly (10 -

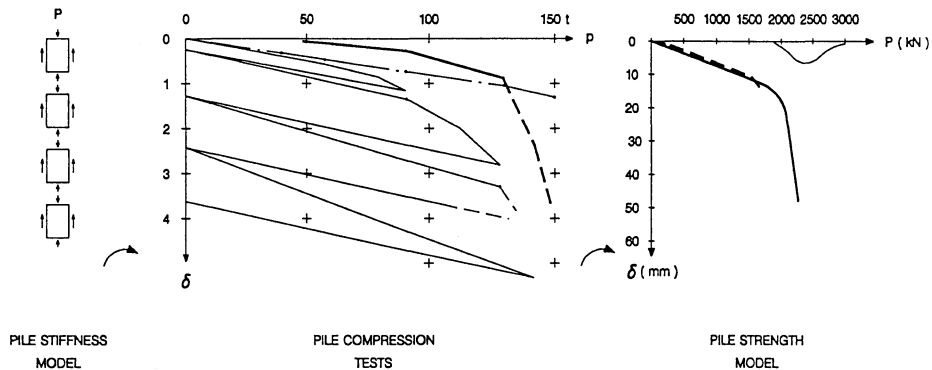
Fig. 5. Illustration of the modelling of the pile compression strength for the test piles which could not be loaded to their ultimate compression capacity.

In advance of each of the tests, the probabilistic model of the pile compression strength was used in order to predict what the result of the next experiment would be, by use of the equation and the model illustrated in Fig. 5. It is worth noticing that all the predicted mean values of the pile strengths were within 10% of the test results.

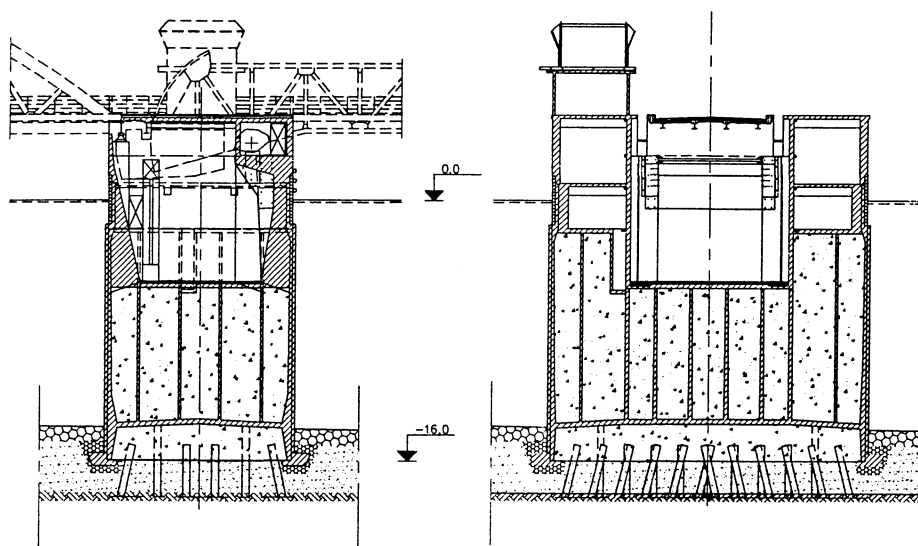
Fig. 1. The bascule pier.

In the late 1970's an approximately 0.4 m thick barrier of reinforced underwater-concrete (Colcrete) was cast around the outer face of the pier below sea level. The barrier was expected to stop excessive ingress of sea water into the pier and deterioration of both structural and mass concrete. The repair proved to have no observable effect on the degradation of the pier and this is ascribed primarily to defects in the construction of the barrier.

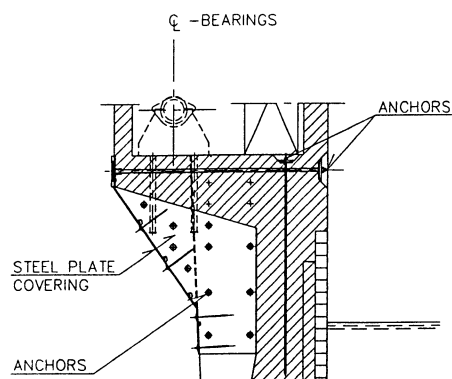
Fig. 2. Repair of the plinth for the bascule bearing.

The repairs in phase 1 were primarily located around the plinths supporting the bascule bearings, Fig. 2, where structural failure was considered imminent due to cracking, deteriorating concrete and corrosion of the embedded reinforcement, combined with the high loads on the plinths from the bascule.

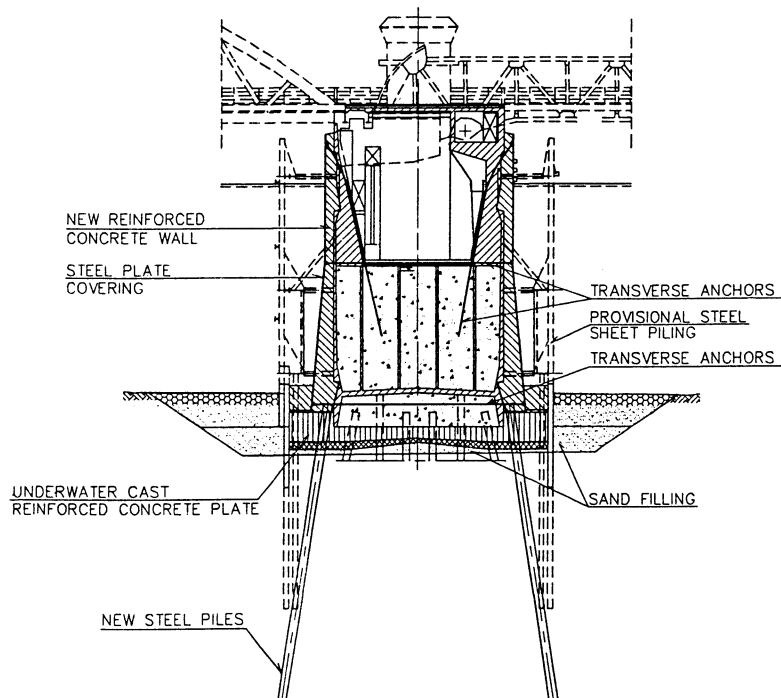
Fig. 3. Repair and strengthening of the bascule pier.

Internal repairs of the pier comprise of conventional concrete repair and extensive injection of cracks, honeycombs and cavities with grout and epoxy-resin. An outline of the repair is shown in Fig. 3.

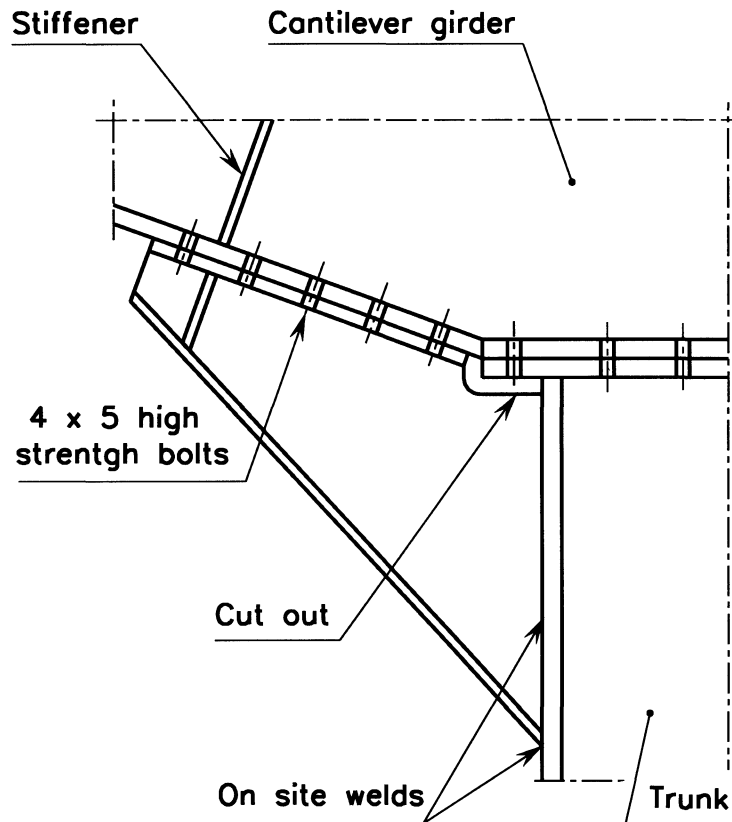
Fig. 2. Reinforcement as designed.

The reinforcement consisted of a short corbel which was fixed under the south cantilever of the transverse girder onto the trunk. It comprised:

- a web, varying in depth from 500 to 80 mm, with a rounded cut out at the lower top angle;
- a top flange, tied to the bottom flange of the cantilever girder with 4 x 5 high strength bolts;
- a bottom flange welded with the web to the trunk through a vertical plate; in order to keep the cantilever girder as a demountable piece of the pier (Fig. 2).

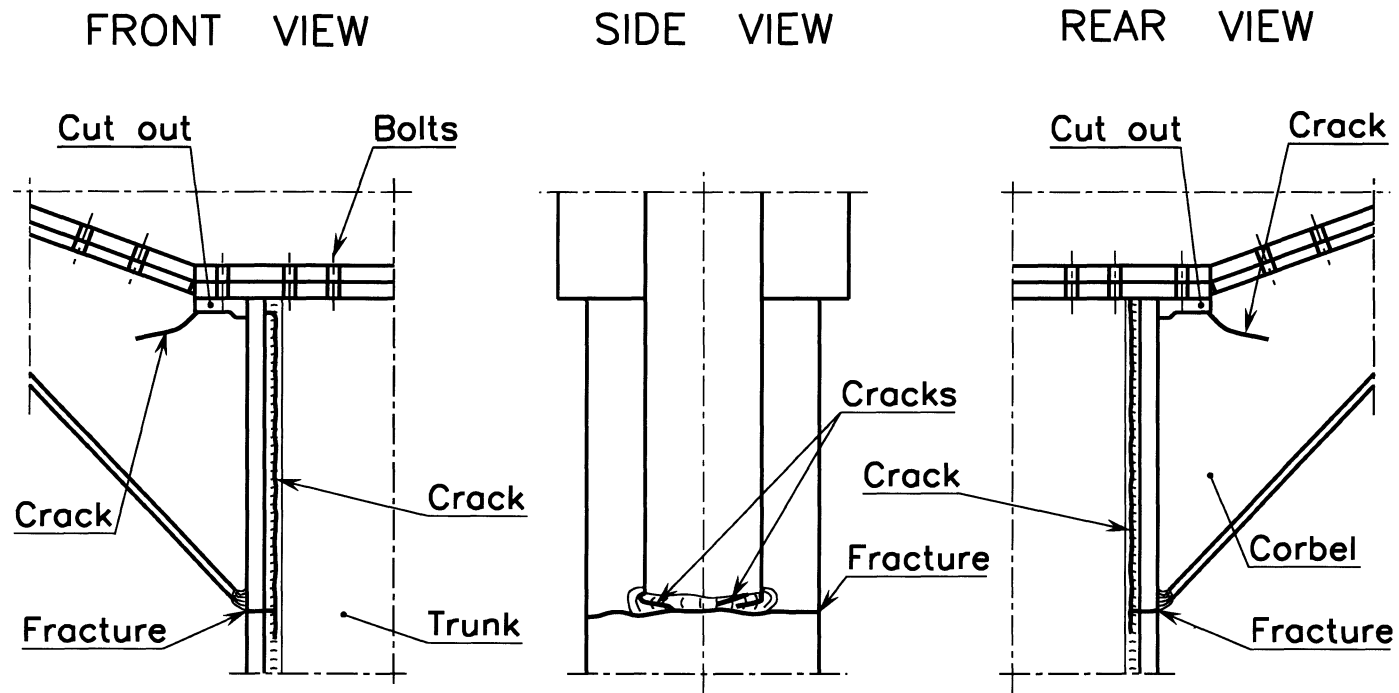
Fig. 3. Cracks and fracture on pier 6 (only damaged welds are represented).

Every other month routine inspections did not note anything until February 1985 when 5 bolts were found broken on piers 6 and 7, still at the south end of the cantilever girder to trunk junction, and these were replaced, as well as 3 bolts fixed in 1982 which were getting loose.

1. in the web, from the cut out at the lower top angle, with a length of 150 mm; in the weld joining the bottom flange to the trunk; and propagated into the flange of the latter, then into the fillet welds on both webs of the box girder. In actual fact the south flange of the trunk was completely broken (Fig. 3).

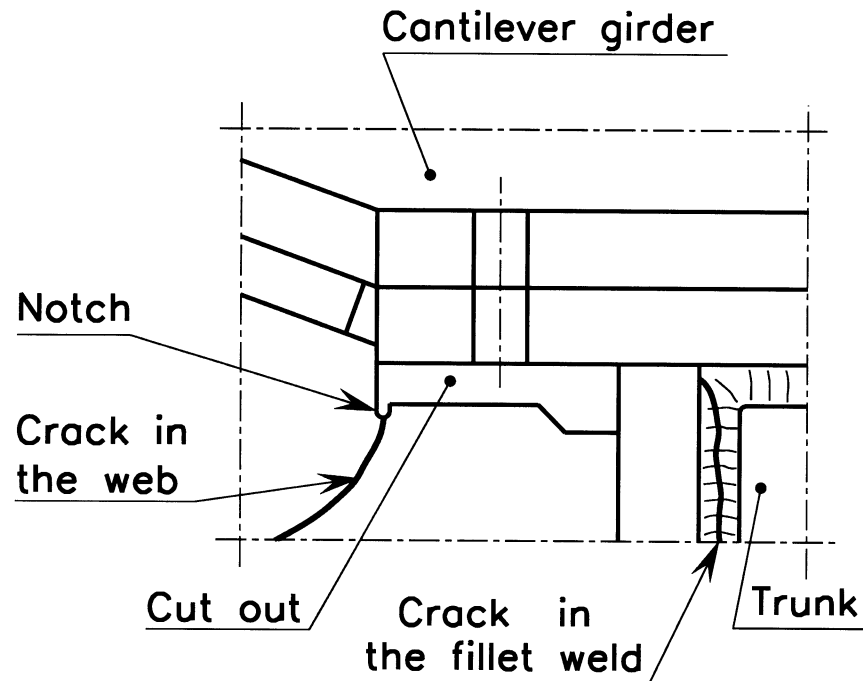
Fig. 5. Detail of the front face on pier 6.

1. the cut out in the web was not rounded, but comprised angles, with a notch from which the crack had developed (Fig. 5);
2. the vertical plate for attaching the corbel to the trunk was missing, for unknown reasons.

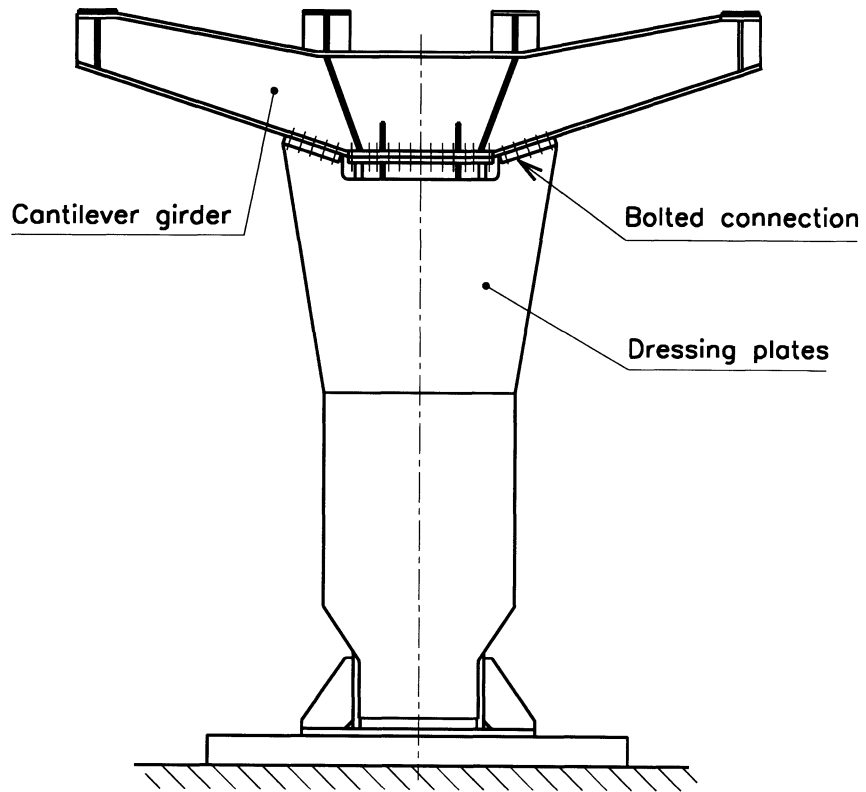
Fig. 6. Second strengthening on pier 6.

As no further damage had occurred up to the opening of the new bridge in 1989, the second strengthening was considered satisfactory. This case history demonstrates the need to pay attention to details, even for temporary bridges.

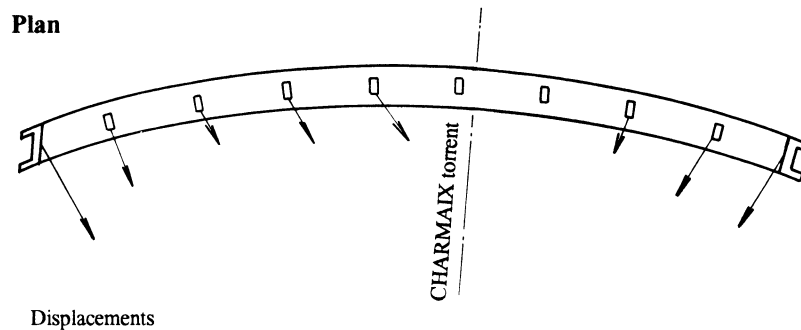
Fig. 1. Ground movements.

The slopes displaced, on several ten metres thicknesses, at a quasi constant speed sliding by 2 cm per year, with an increased speed following the melting snow. Some pier displacements were approximately 20 cm in length, along the slope (Fig. 1).

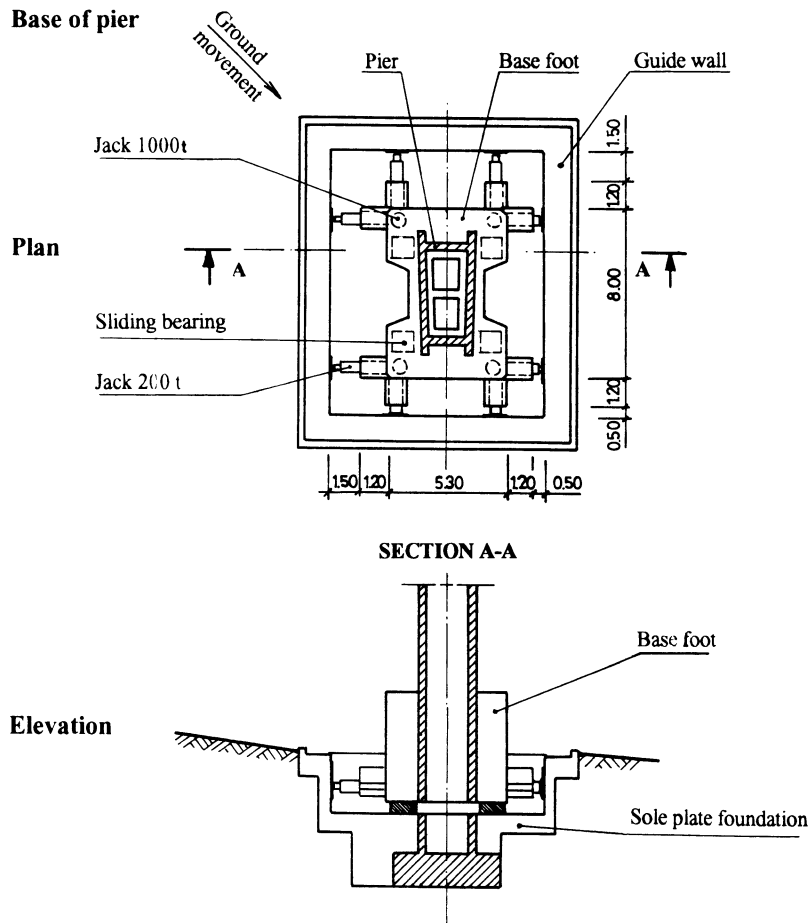
Fig. 2. Details of pier jacking arrangement.

Periodically, the company has had to move back the piers to hold the viaduct in position.

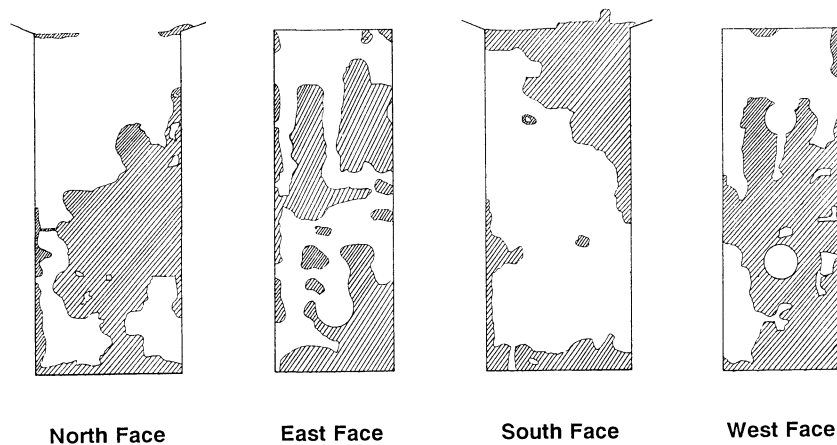
Fig. 2. Delaminated areas of Pier 2.

1. *Visual condition:* The visual survey demonstrated that extensive spalling and cracking of concrete existed in large areas on random positions of the piers, with the greatest damage occurring on Pier 2 (Fig. 2). In all cases the damage consisted of delamination and spalling of the concrete from the horizontal link reinforcement which was fairly extensively corroded. In most cases the main reinforcement was not severely corroded. A thermo-graphic survey was carried out for Pier 1 to confirm the visual survey and sounding test results. On the internal surfaces of the piers the extent of spalling and delamination was very much reduced (about 10% average).

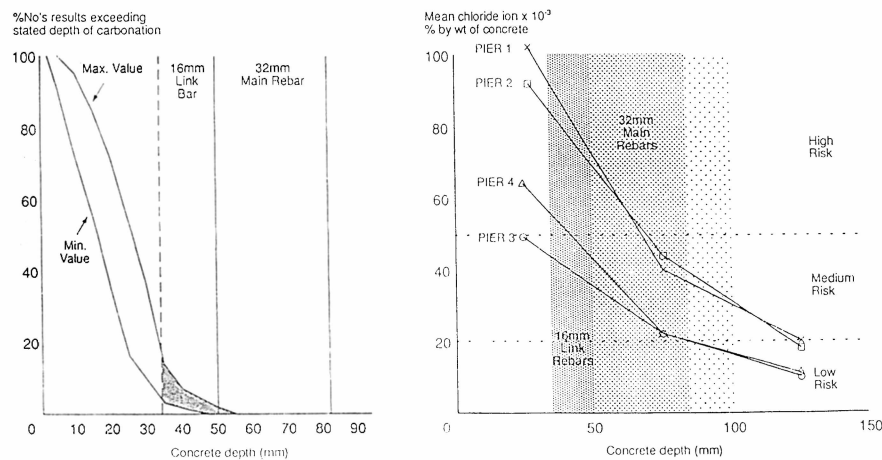
Fig. 3. Extent of carbonation and chloride ingress.

4. **Chloride content:** This was determined by taking drillings at incremental depths of 5-50 mm, 50-100 mm and 100-150 mm into the concrete. On the external faces of the piers nearly every set of drillings showed decreasing chloride content with depth from the surface (Fig. 3). On the internal faces, this profile was not so marked and the chloride values were much lower.

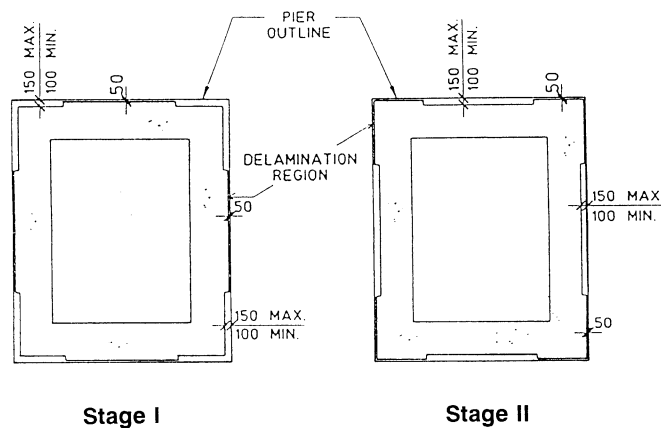
Fig. 4. Bridge pier repair stages.

To verify this two stage proposal, two pier breakout sections to resemble the piers were considered in the checking of stresses during repair (Fig. 4).

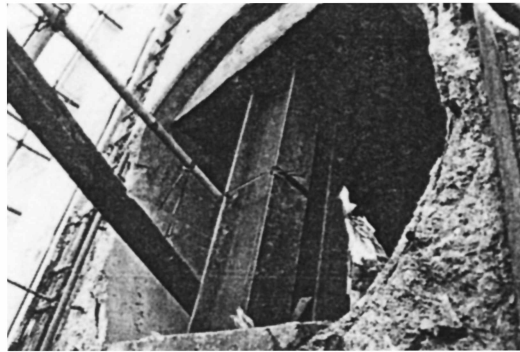
Fig. 5. Temporary strutting to ventilation openings.

At the ventilation openings, the pier cross section is reduced and the stresses are much higher than those in the typical section. Temporary strutting to these openings (Fig. 5) was therefore employed during the whole course of repair. Restriction on HB type vehicles using the bridge was imposed during repair, as they were not allowed for in the original design.

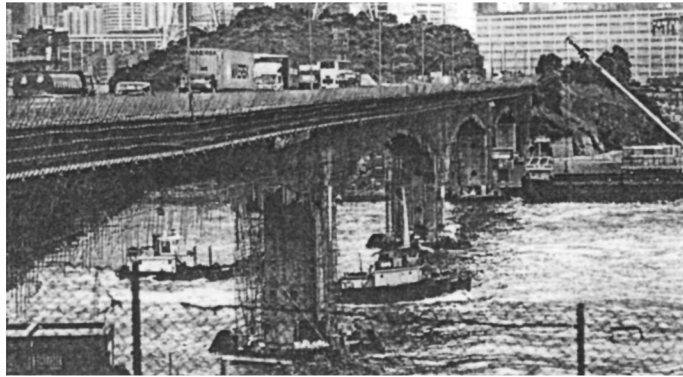
Fig. 6. The bridge under repair.

Patch repair for the pier internal surfaces could be carried out immediately after repair concrete of the external face of the same pier had reached the specified strength. Patch repair for the arches could be carried out at any time before the final protective coating was applied.
