# RAILWAY ACCIDENTS

Greg Morse

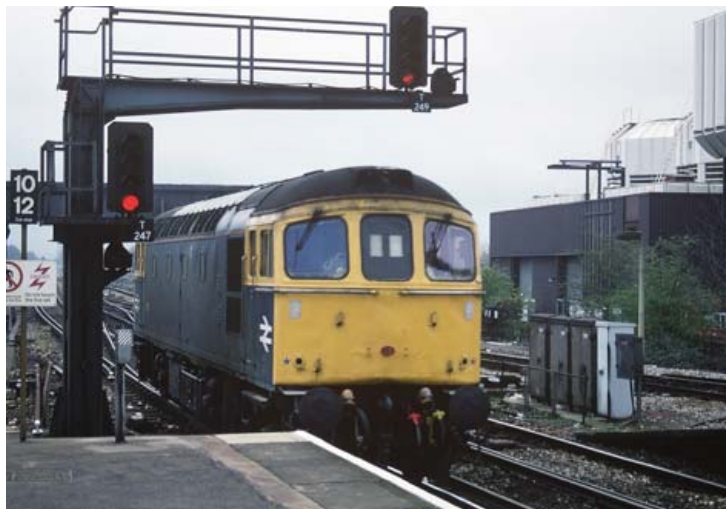
The railway's sentinel of safety has long been the signal. This 'cantilever' has 'heads' protecting two lines. It looks as though 33211 has committed a 'signal passed at danger' incident – a SPAD. In fact, the signal has returned to red in order to protect the locomotive as it continues its journey.

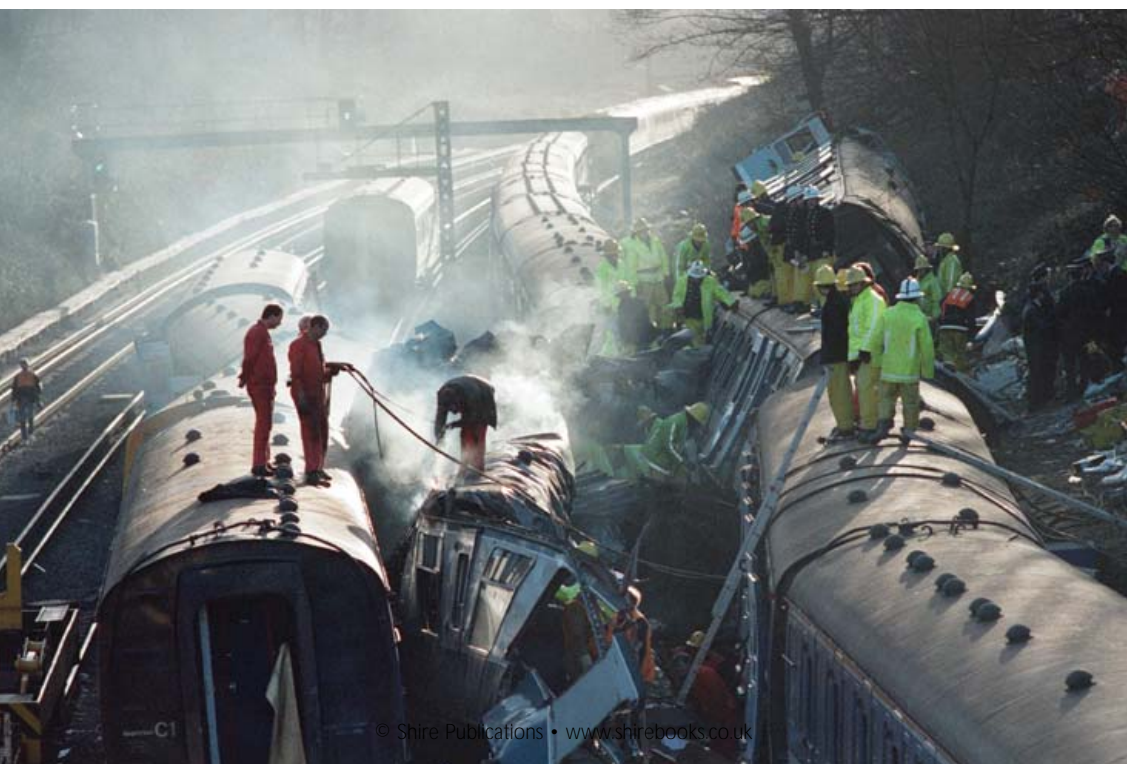
The Clapham collision of 12 December 1988. Here, firemen and engineers are cutting through the wreckage in the search for survivors.

The resulting inquiry found that a live wire had been left dangling in a relay room; when jolted a couple of weeks later, it touched a terminal, made a connection and prevented a signal from returning to 'danger' after the passage of an earlier train. Beneath this surface failure, investigators also found problems with management, supervision, training and rostering. It's a basic truth about accidents: that there's always more than one cause. Thus, at Bellgrove Junction on 6 March 1989, a driver passed a signal at 'danger', true, but the fatal collision that followed would not have come had the guard not given the 'right away' while the red light was still shining, or if BR had not altered the track layout in such a way that a SPAD could put one train into the path of another.

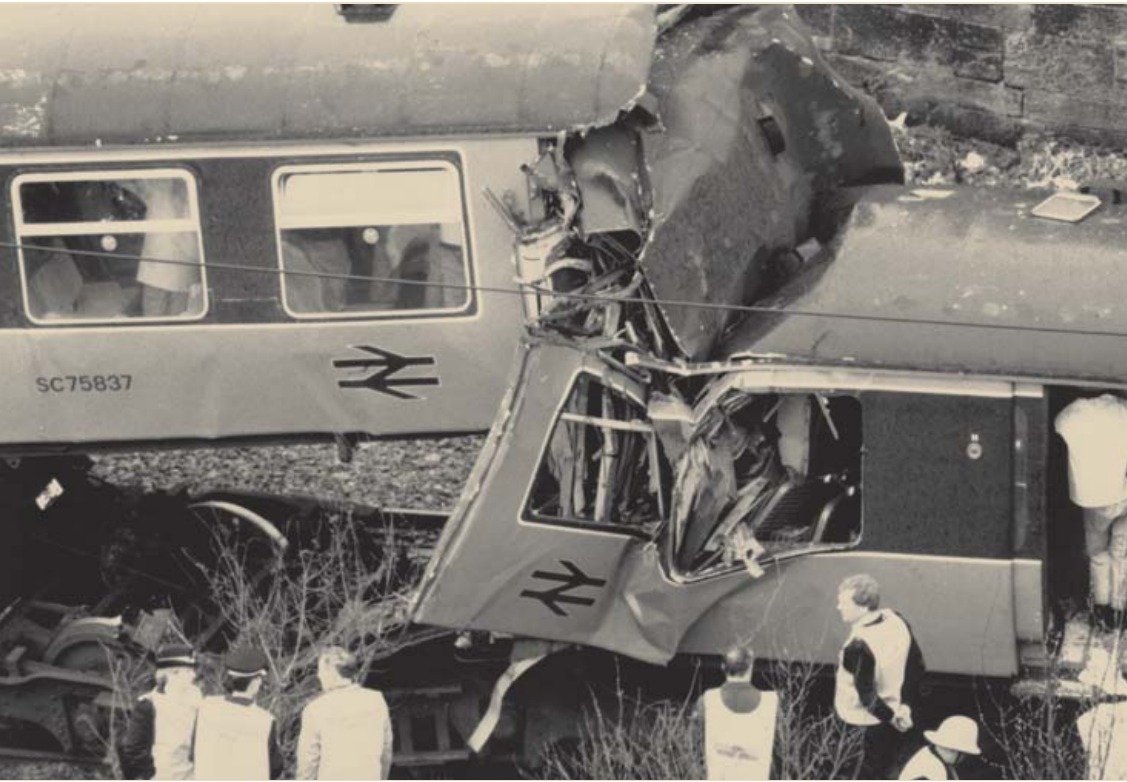
In the causal chain of the fatal accident at Bellgrove was the simplification of the junction from a double-track arrangement to one which included a short stretch of single track.

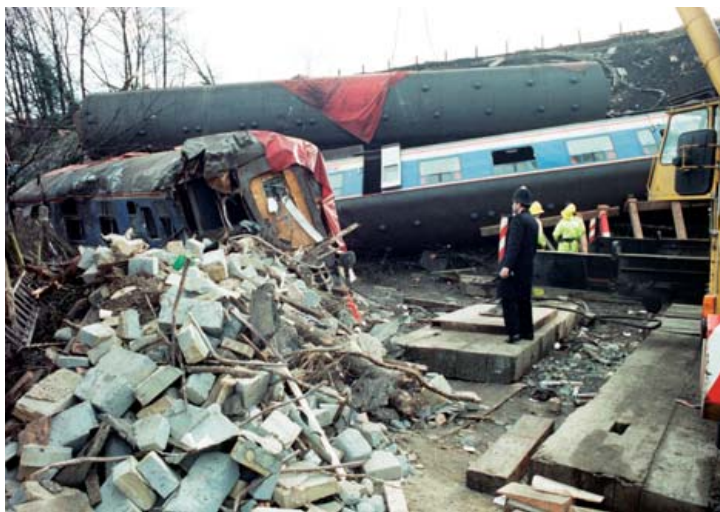
The same signal had been passed at 'danger' four times before; such things are seldom coincidental, and often suggest that the position of the gantry or post makes the head prone to being overlooked. In this case, though

drivers had slightly longer to see the signal while in motion than the seven seconds considered acceptable for a 90-mph line, it became obscured by the station buildings as the train approached. The investigating officer recommended that erecting a repeater would lengthen this ‘sighting time’ and help cut the number of SPADs at the signal itself. The “new evidence” was accepted by the court in 2007 and the conviction overturned. Sadly, the driver would live with his good name restored for just two more years.
